Manhole Inspection Summary

Manhole # S07SS_009MH

Insp Date: **7/19/07 10:41 AM**

Location Address: **3712 POWHATAN AVE**

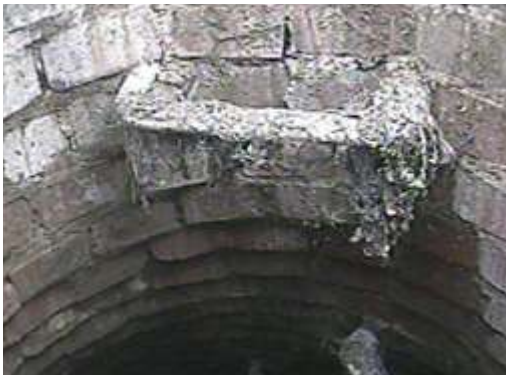
Defect 1

Steps Count: **3** Missing: **0** ☒ **Corroded**

Surcharge ☒ **Evidence Of Surcharge** Depth: **4** (ft.) ☐ Active Surcharge Present

**SURCHARGE EVIDENCE AND
CORRODED STEPS**

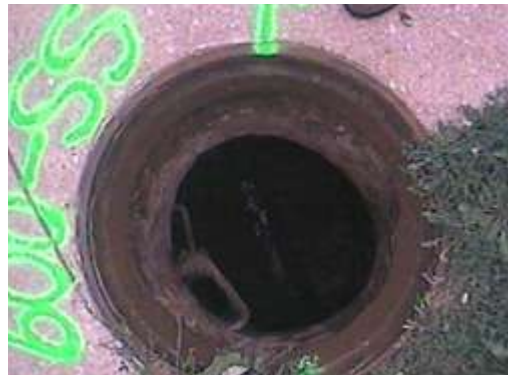
Defect 2

Frame Offset: **2** (in.) Condition: ☒ Sound ☐ Cracked ☐ Leaks

FRAME OFFSET

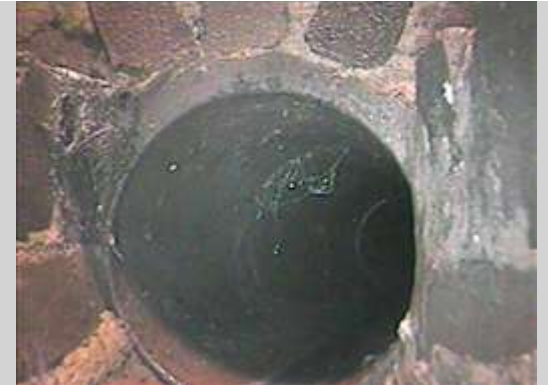
12 O'Clock Outflow

8 in. Circular Gravity Sewer
Pipe Out @ 12 O'Clock

Pipe Material: **Clay** ☐ Pipe Lined

Invert Depth: **7.05** (ft.) Flow Characteristics: **Slow**

Infiltration: **None** Pipe Seal Cond: **Sound**

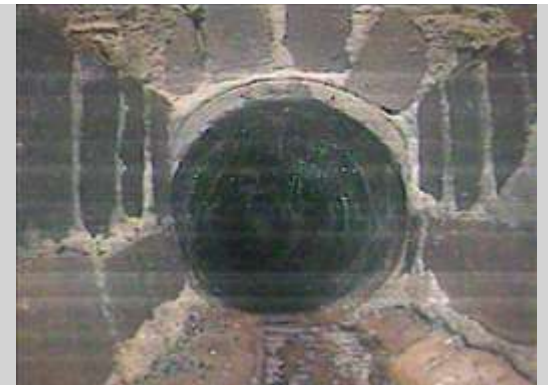
5 O'Clock Inflow

8 in. Circular Gravity Sewer
Pipe In @ 5 O'Clock

Pipe Material: **Clay** ☐ Pipe Lined

Invert Depth: **6.78** (ft.) Flow Characteristics: **Slow**

Infiltration: **None** Pipe Seal Cond: **Sound**
